# MECHANICAL ISSUES WITH FLOATING TABLE TOP

**APPLICABLE TO:** All systems using the two column table:

**INFORMATION:** This instruction covers how to find the most common root causes when having

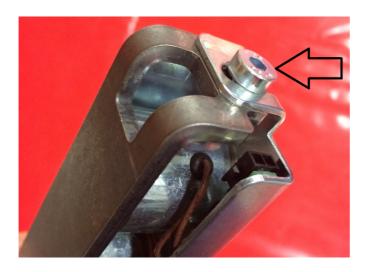
- 8. Check table top brakes for visible damage.
- 9. All brakes should release consistently when the foot control or handle button is pressed. If the X-brakes doesn't release the reason could be that the distance between anchor and magnets are too large. In that case, add shims to decrease the distance (see step 12).

- a. Brake plate can be adjusted in relation to the magnets:
  - i. Activate the brake
  - ii. Loosen the screw in the photo to the left.
  - iii. The activated magnets will pull the plate home.
  - iv. Using new Loctite 243, retighten the screw.

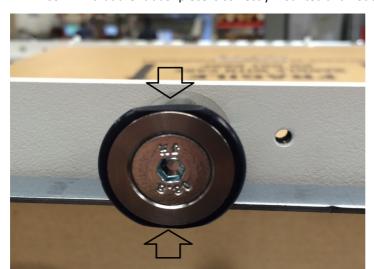
11. End stop rubber is mechanically adjusted to move clear inside table top. Confirm that the rubber piece is correctly mounted and not turned:

The flat surfaces should point upwards and downwards.
