“OTC column stuck in upper position”

APPLICABLE TO:	Precision system
ERROR MESSAGE:	[No error message present]
INFORMATION:	This instruction covers how you move the column downwards again in case it is stuck in upper position.

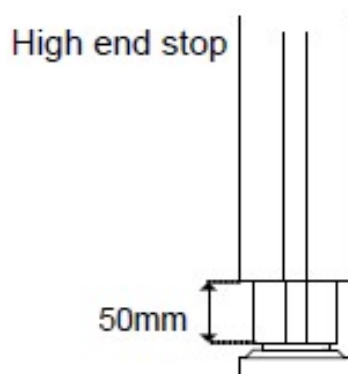
The correct position for setting the high end stop is shown in the picture below.

The Z high end stop is calibrated from factory, only perform the calibration if necessary.
