# "AUTOPOSITIONS ARE DRIFTING"

APPLICABLE TO:	Precision system
ERROR MESSAGE:	[No error message present]
INFORMATION:	This is an error related to motorized movements only. There is no error message present since the system actually considers itself in the correct position - but mechanically it is not.

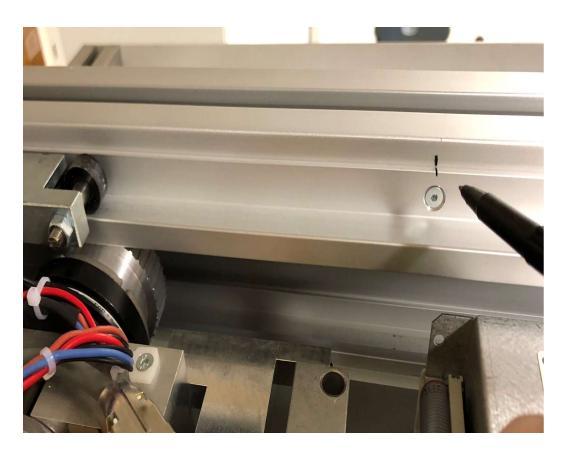
We can then later look at the marks and see if they still match – if they don't, it means there is something mechanically wrong in the system.

- Also make a mark at tooth belt and rail:
