1 Introduction

The Arcoma Precision system will display system messages on the OTC display, imaging system monitor and in log files during normal use and in error situations. This document contains information about those messages and suggested actions to be taken by service personnel to correct malfunctions that may occur.

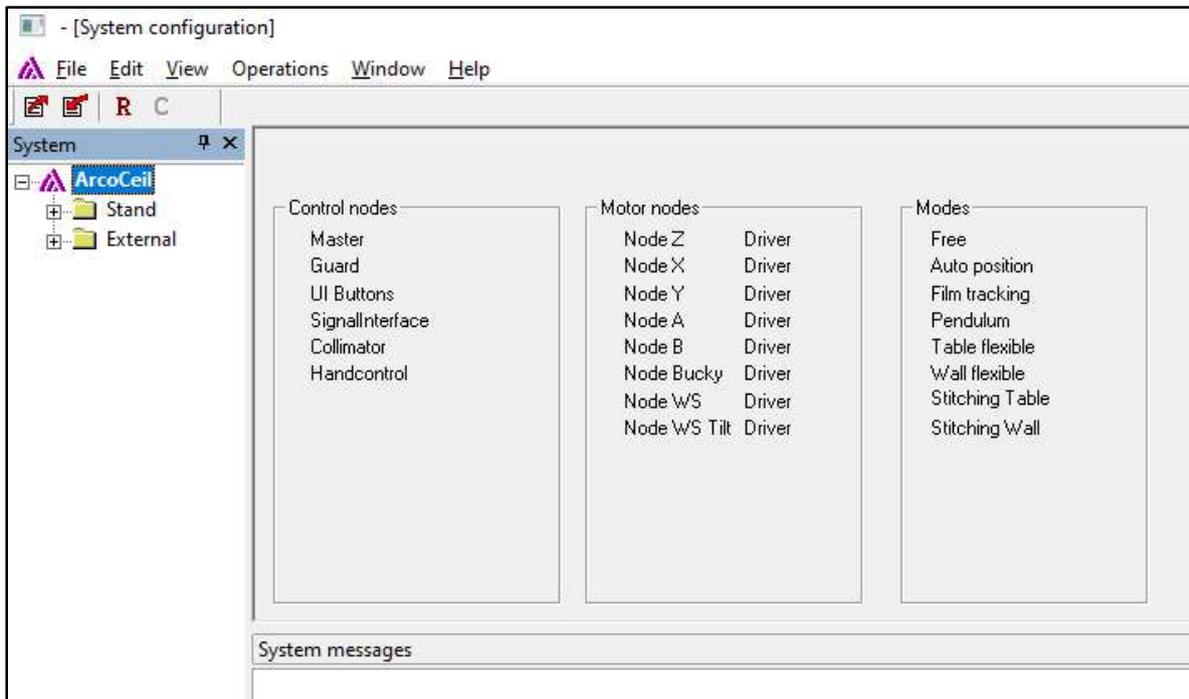
Automatic movement error

The mode for the requested autoposition is not valid

Node: 0xF, Component: 0x10, Reason: 0x33, Extra: 0x90C

Reason: Extra: 0x90C where 9 means *Autoposition number 9* and 0C means *Mode Stitching table*.

In the example above, Autoposition number 9 is set up for Stitching table mode. This mode is not included in the system.

Action: Recalibrate affected autoposition with an available mode. Upgrade the system with stitching functionality if required. If this error occurred after OTC Master/Z node replacement. Use hardware key (HWK) from original node in the new spare part.

Reference: Use ArcoCeil service program to check if the required mode is available.
ArcoCeil => Modes.

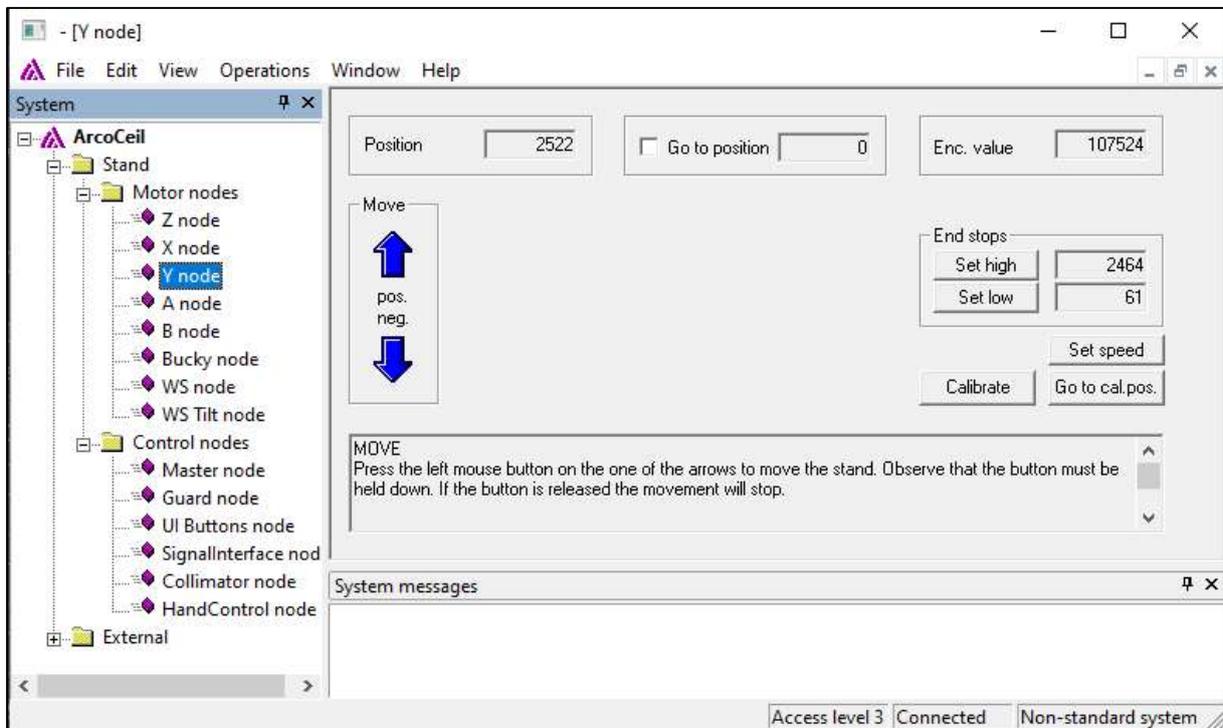
Automatic movement error

The requested position for a node is not valid. Not possible to move to.

Node: 0xF, Component: 0x10, Reason: 0x32, Extra: 0x7

Reason: Extra: 0x7 where 7 means Node Y. See Table 1.

The selected position is not possible to move to.

Action: Confirm that the auto position address is set within end stops for all included motor nodes. Move the OTC to the required position manually. Use the ArcoCeil Service program to establish that the position is within the software end stops for the reporting node. See example below. The required position for the Y axis (2522) is outside the calibrated end stops (61-2464). This position is not possible to move to. Recalibrate end stops or autoposition.

NOTE! The collimator top- or bottom centering setting can affect positioning. Keep this in mind when analysing this error message.

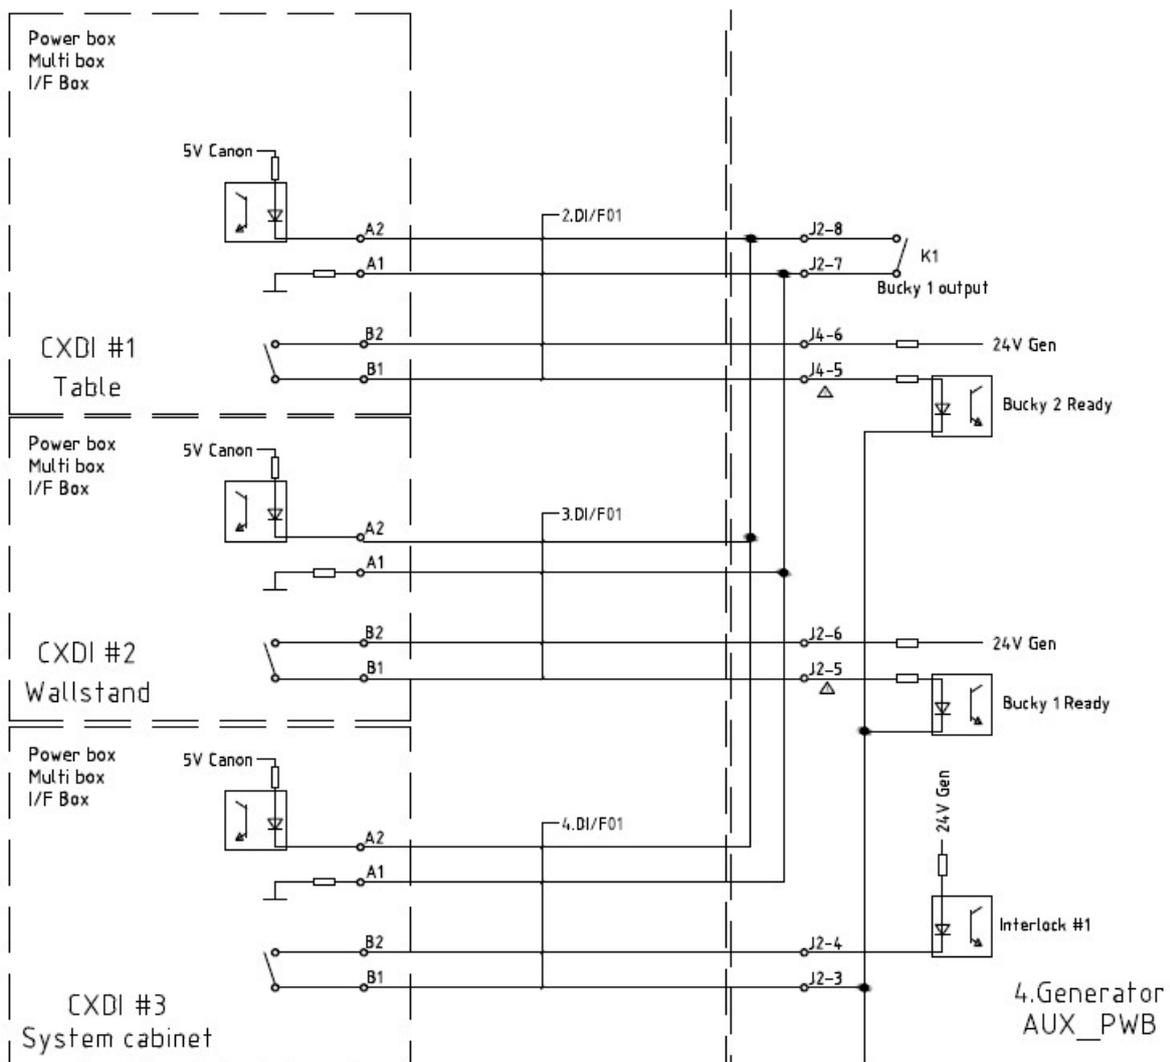
Bucky 1 Interlock error [78]

Reason: Response on an exposure request from the generator was not returned from the interface box in Wall stand.

Exposure was inhibited as the detector ready signal did not reach the generator Bucky Ready input Bucky 1 Ready J2-5 J2-6 (Generator AUX-board).

Action: Follow trouble shooting guide 0200-095-206 to investigate protocol settings, generator settings and electrical connections.

Follow the appropriate System Block Diagram (SDB-C) to check the detector configuration of the specific system. Note that an SBD drawing is available for each individual detector configuration. See also UBD_C_Image system and MD-0930.

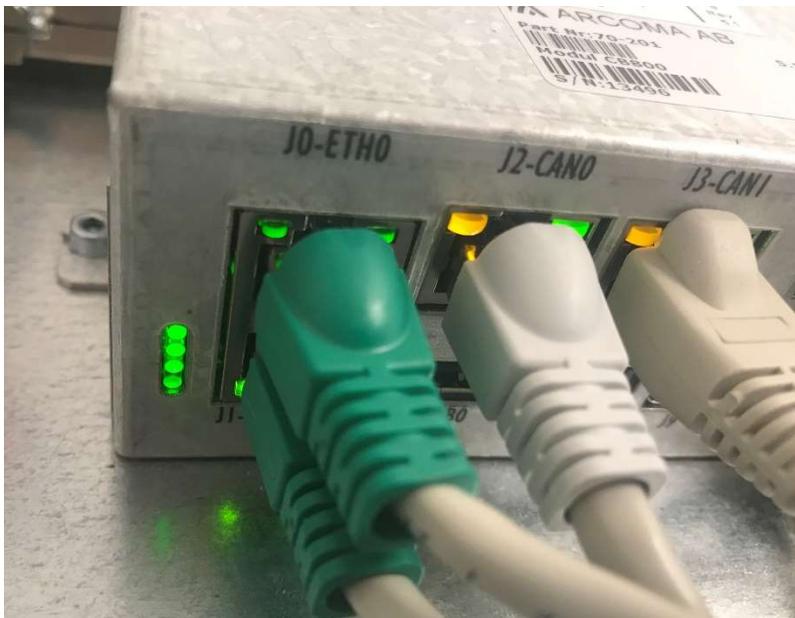
Cannot communicate with Table system

Reason: This error message can show because of a generator restart or a generator communication failure. A repeated message indicates that the Ethernet communication between PC (overwrap software) and CB800 was interrupted or not established. This error is often followed by a Generator offline error and/or a DAP device error.[72].

Action: Confirm that the system is switched ON from the generator mini console. Check Ethernet cable connection ETH1 on PC and connector J1-ETH1 on the 4.CB800 module. Confirm that Firewall is turned off on PC or that firewall settings allow this communication.

Use the *Command Prompt* to ping the SystemMaster (CB800 module) on IP-address 192.168.0.1

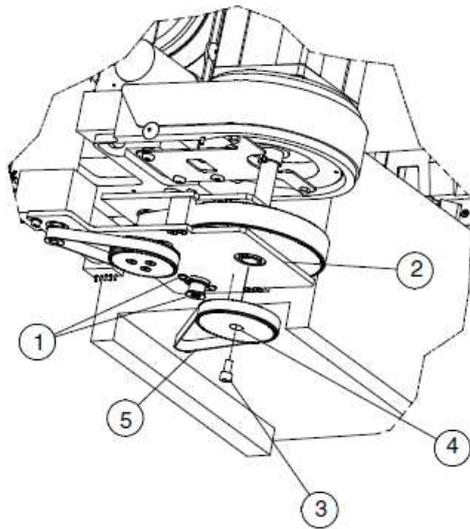
Check tooth belts and mechanical attachment points for beta axis.

Center screw (item 3) being loose will cause this problem.
