# "AUTOPOSITIONS ARE DRIFTING"

APPLICABLE TO:	Precision system
ERROR MESSAGE:	[No error message present]
INFORMATION:	This is an error related to motorized movements only. There is no error message present since the system actually considers itself in the correct position - but mechanically it is not.

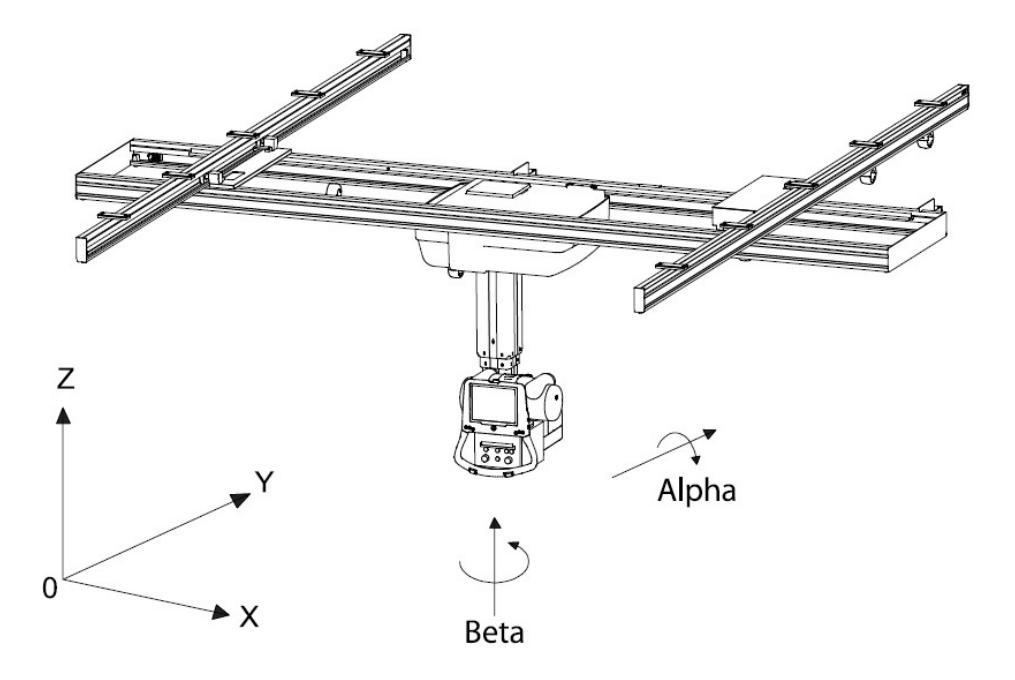
BUT – the first step before we move forward is to determine which direction to deal with. These are the directions we will refer to in this document:

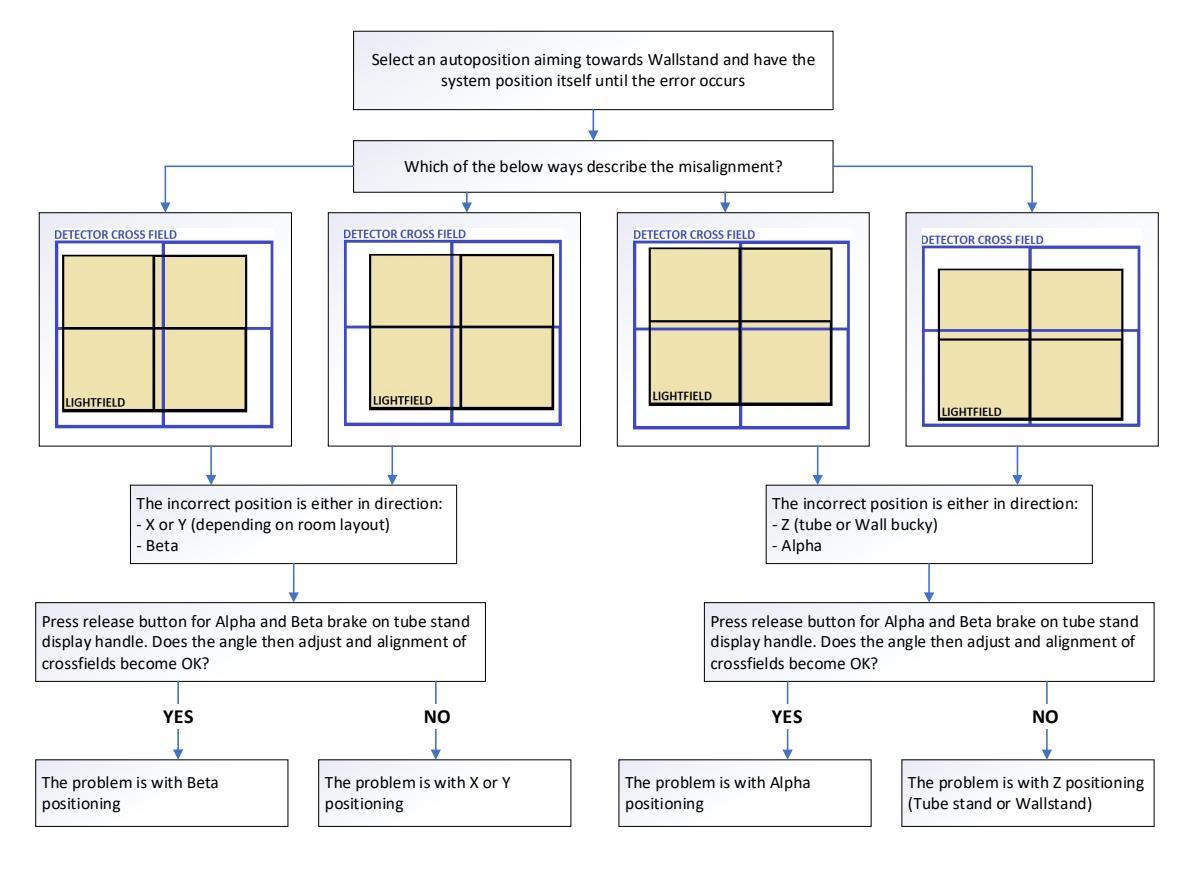
## WALLSTAND

**2.** See and follow the flow chart on next page to determine this – one for positioning against Table and one for positioning against Wallstand, depending on your situation.
