# MECHANICAL ISSUES WITH FLOATING TABLE TOP

**APPLICABLE TO:** All systems using the two column table:

**INFORMATION:** This instruction covers how to find the most common root causes when having

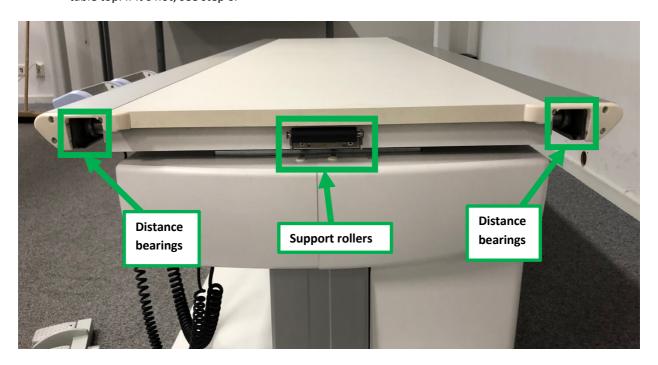
- 1. Check the table top for possible damage from collisions or similar that could explain deteriorating function
- 2. Confirm that the table top is plane and does not come in contact with table frame or its *support rollers* at normal load.
- 3. Confirm that all *distance bearings* except the four corner ones, is adjusted in its <u>highest</u> position. The bearings are excentric and can be adjusted using the tool that was part of the delivery. The corner bearings are normally mounted in its <u>lowest</u> position but may sometimes be raised to prevent noise when moving the table top towards the end positions.
- 4. All distance bearings must be firmly mounted. If they become detached it could cause movement issues. Tighten with 10Nm.
- 5. Confirm that the table top is positioned so that the distance bearings perfectly fits the tracks of the table top. If it's not; see step 6.
