1 Introduction

The Arcoma Precision system will display system messages on the OTC display, imaging system monitor and in log files during normal use and in error situations. This document contains information about those messages and suggested actions to be taken by service personnel to correct malfunctions that may occur.

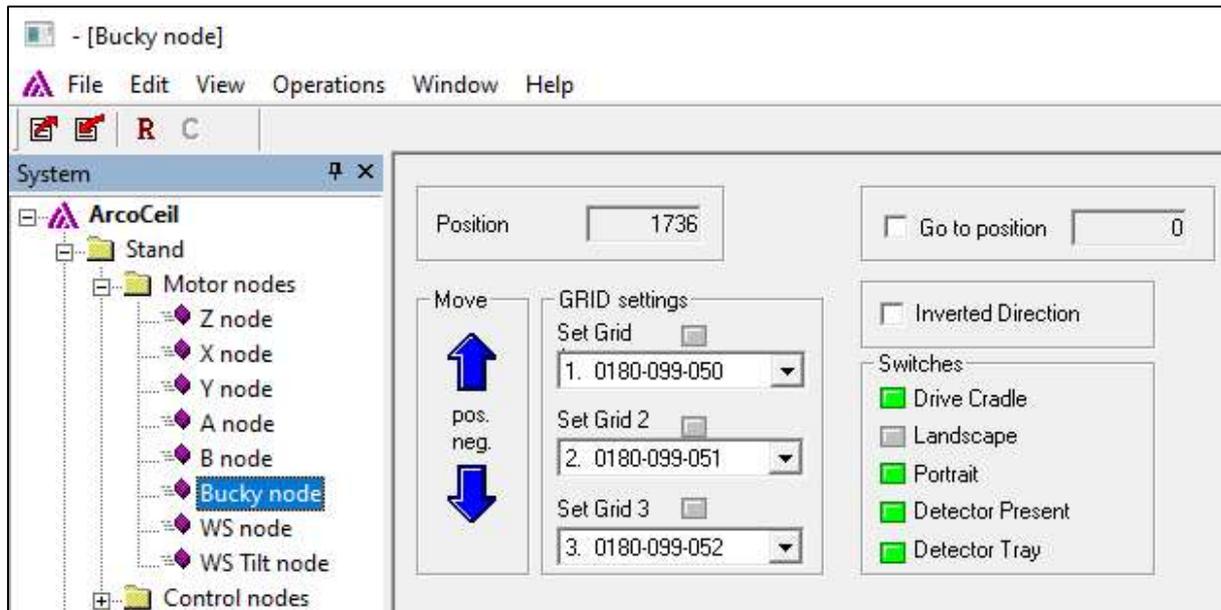
Confirm that the related microswitch inputs are highlighted in the ArcoCeil Service program.

NOTE! Detector must be placed in either Landscape or Portrait position for the system to allow exposure.

Confirm that correct workspace / receptor is selected. Switching workplace without reactivating the servo will result in this error.

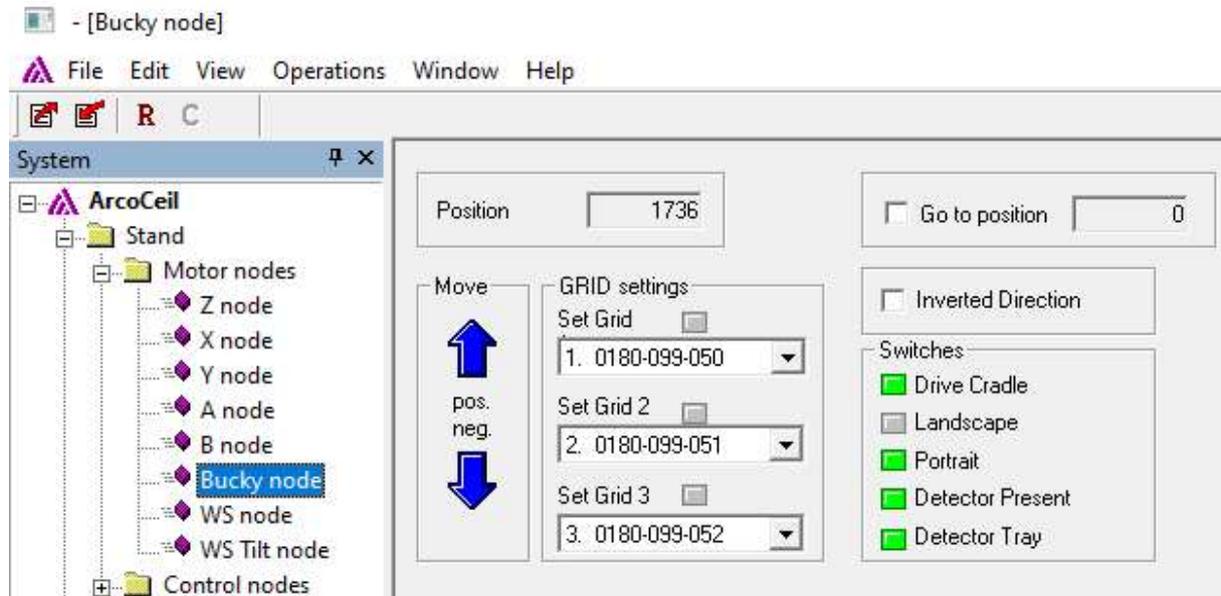
Action: Place bucky tray in correct position and reactivate mode. Confirm that the input from the Detector tray microswitch is highlighted in the ArcoCeil Service program.

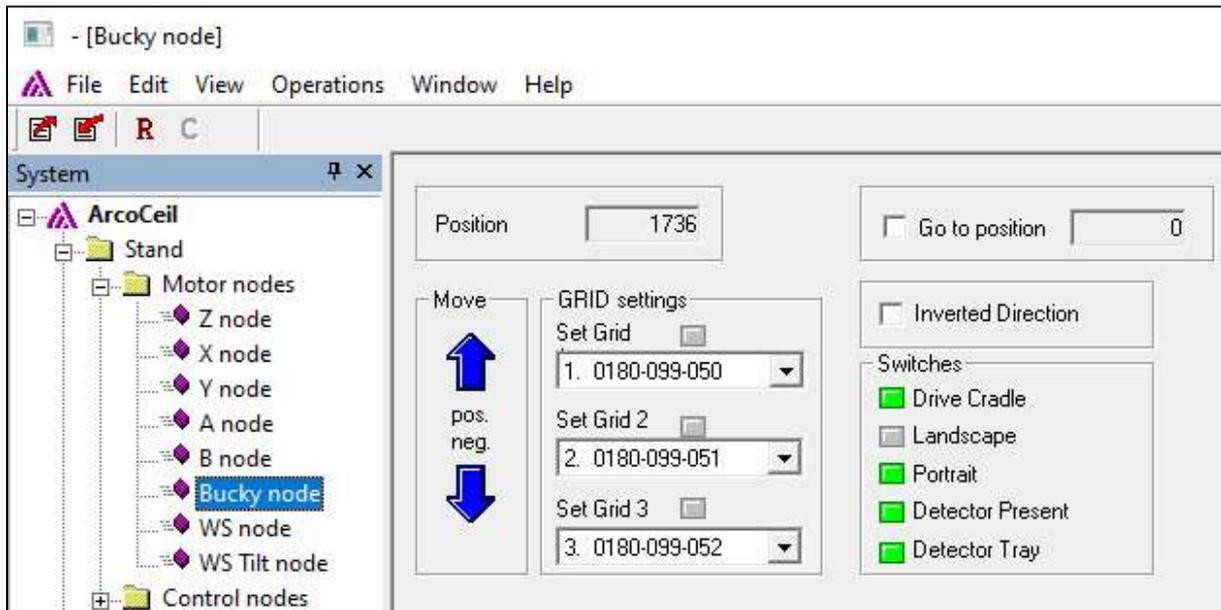
Confirm that the related microswitch inputs are highlighted in the ArcoCeil Service program.

NOTE! Detector must be placed in either Landscape or Portrait position for the system to allow exposure.

Confirm that correct workspace / receptor is selected. Switching workplace without reactivating the servo will result in this error.

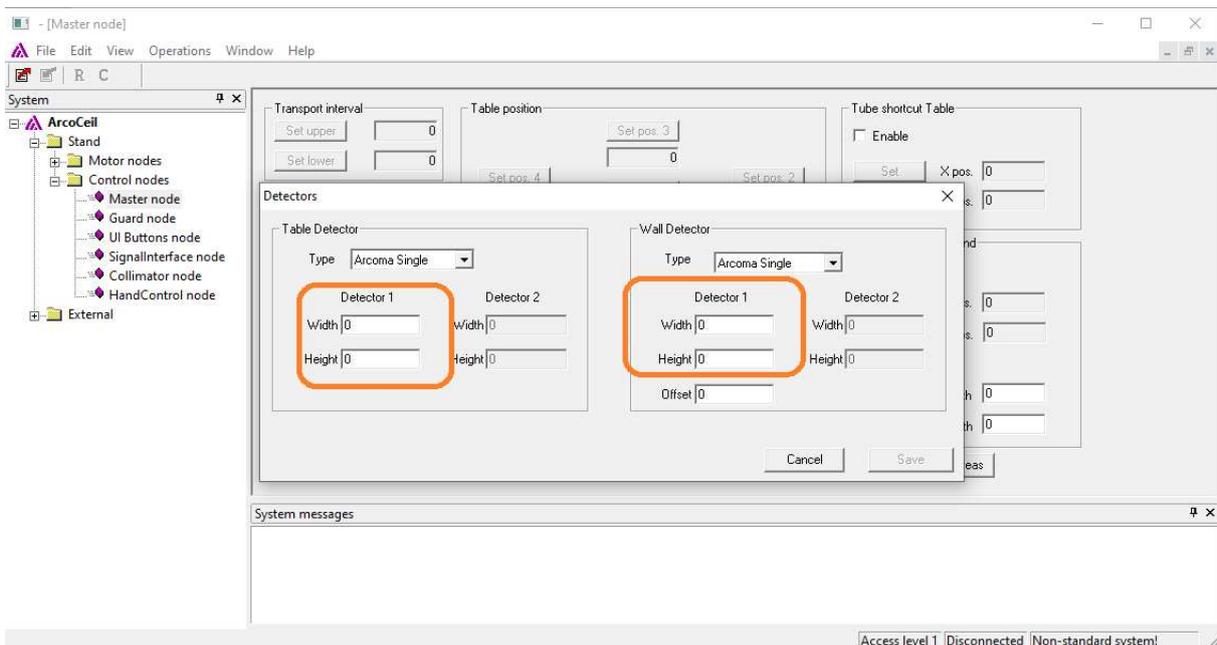
Action: Check detector size settings in Arco Ceil service program. If found correct. Change requested value in the affected APR to a valid size.
